Testing of the Oil Recovery System  
At  
Tha Chana Palm Oil Co., Ltd.  
On  
April 21-2010 to April 29-2010

**iMiQ Engineering Co., Ltd.**

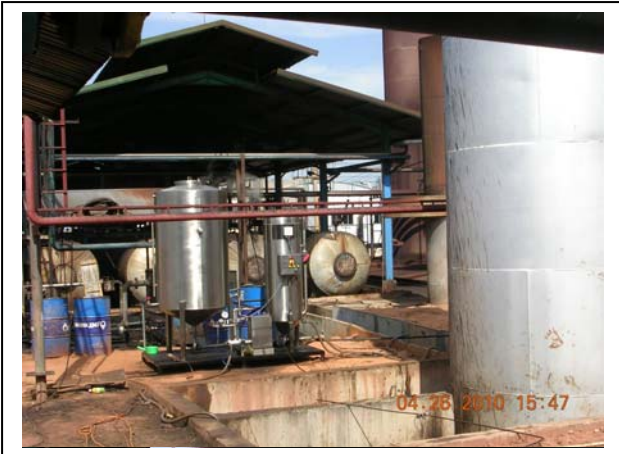
The test unit at site; situated at the end of the sterilizers, next to the pit where oil from sterilizers, from decanters, from sterilizer blow down and from the oil recovery tanks sludge drain all meet. The test unit has a treatment capacity of 500 liters/hour. It is designed for operation of waste water with oil content between 15 % oil and 0.8 % oil. The recovered oil should be with less than 2 % moisture

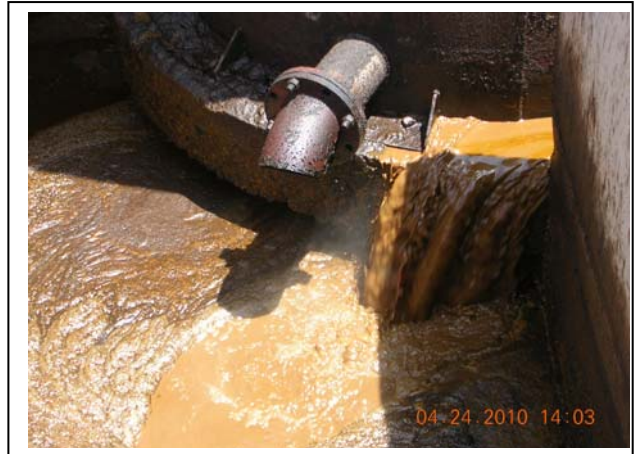
A view into the pit from where all the POME is collected and from where it is pumped to the two existing oil recovery tanks

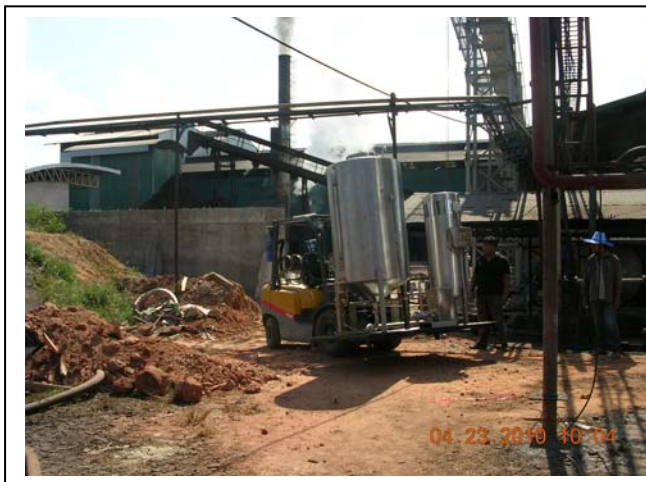
The test unit arrived from Malaysia with a 2 days delay, but luckily without any damage. The unit was assembled, moved to the site next to the POME pit, where steam supply for heating of the unit (90 Deg C) was arranged. The test unit was filled with water and made ready for operation on the following day

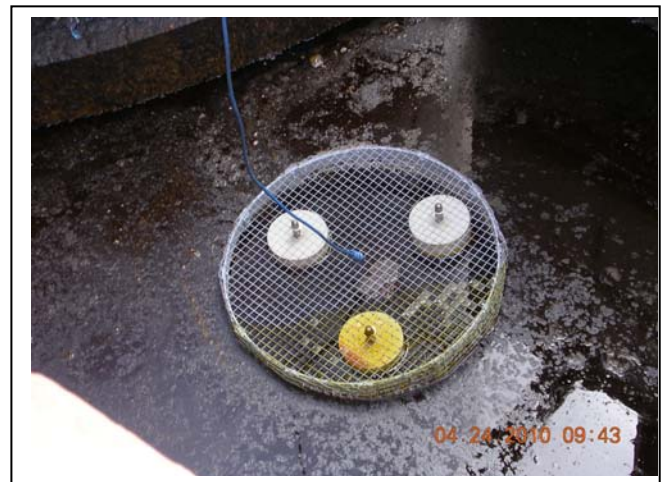
A view into the POME pit where the oil skimmer now has been placed ready for operation

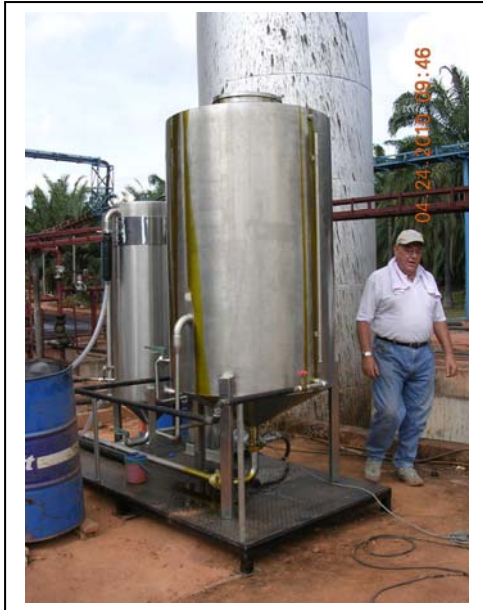
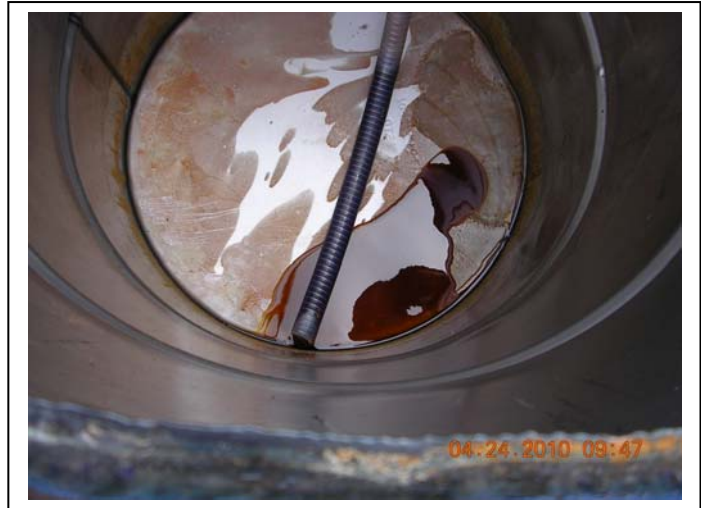
Right after the incident with overflow from the pretreatment tank the first recovered oil started to flow from the test unit

After a short time of operation CPO started flowing from the top of the pretreatment tank. The unit was stopped and the incident investigated, adjustments were made and the testing continued. Later the incident occurred again and a throughout investigation identified a piece of plastic folio blocking a butterfly valve. The valve was removed and thereafter the unit was running without any further problems

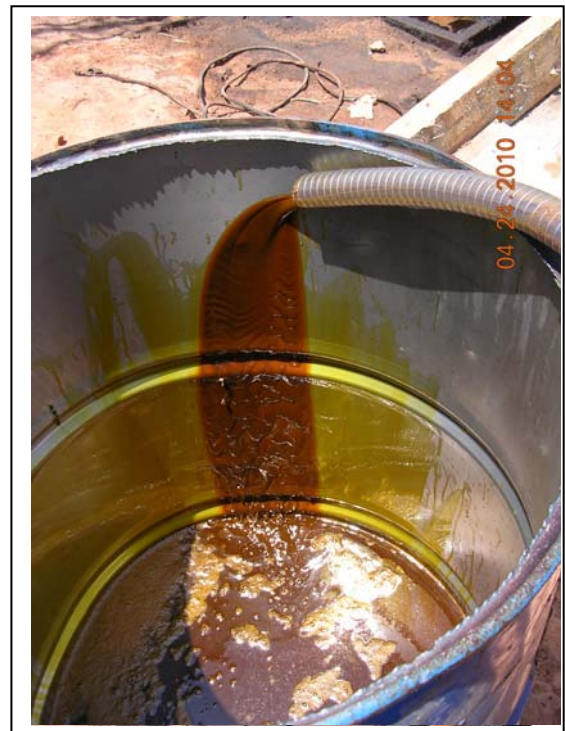
The oil recovered during the afternoon of April 24, the first day of testing the oil recovery unit. Note the relatively dark color of the recovered oil. The dark color indicates that this is **not** fresh CPO.

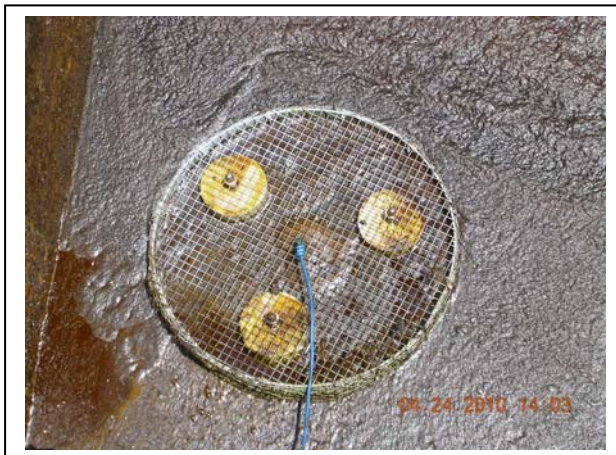
During the first day of the testing the pit surface was covered with a thick layer of old partly hardened oil and it was expected that the Free Fatty Acid content would be high. The analysis later proved the expectations, the FFA was 19.47 %

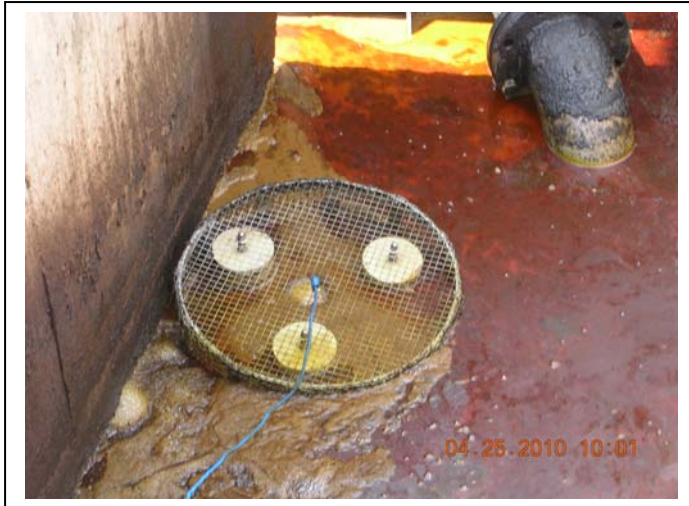
In the morning of April 25 most of the old dark oil had been removed, and more CPO like oil covered the surface of the pit. It is believed that POME running into the pit is mainly coming from the canal collecting POME from underneath and around the sterilizers. The canal outlet to the pit is seen in the top center of the picture.

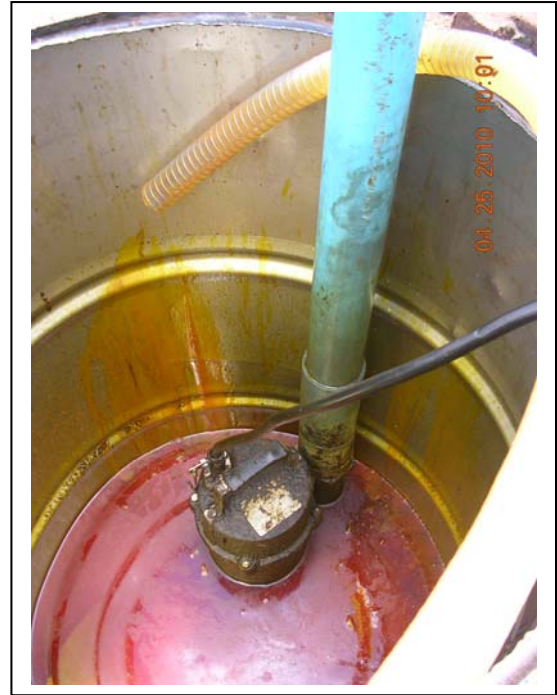
The oil being recovered during the morning of April 25 later proved to have an FFA % of 5.71 % and the impurities were as low as 0.07 %. Unfortunately the oil loss in the effluent from the test unit was not measured

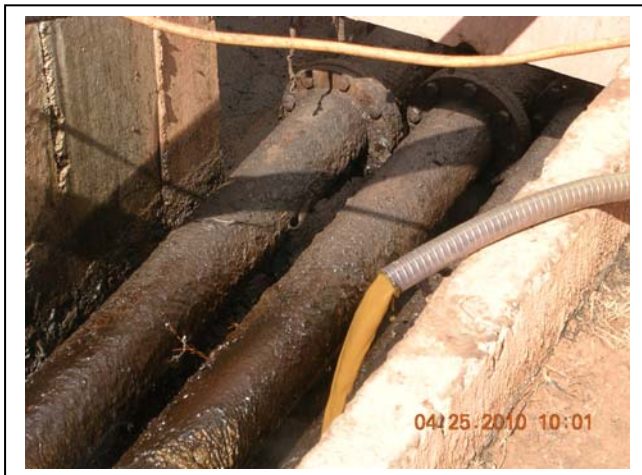
The effluent from the test unit is sent back into the POME collection pit. The pipes seen are from sterilizer blow down and the canal below the pipes is leading POME from underneath and around the sterilizers to the pit.

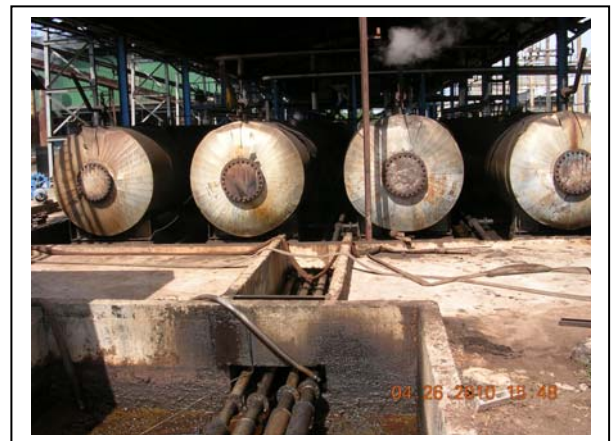
The sterilizers blow down pipes and the canal from the sterilizers leading to the pit.

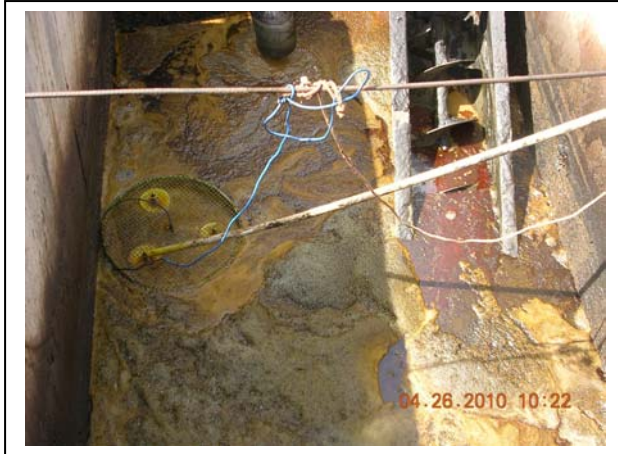
In the morning of April 26 the surface of the pit was covered with a layer flotation sludge and dark oil. It proved to be the result of sludge blow down from the existing oil recovery tanks.

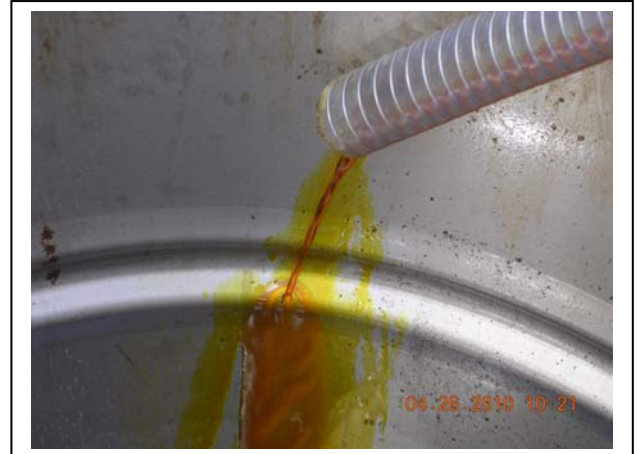
Even though the oil in the pit was mainly from the oil recovery tank blow down, the oil recovered by the test unit seems to be quite clear and transparent. The FFA in the recover oil was 7.11 %, the moisture was 0.57. Impurities were not measured

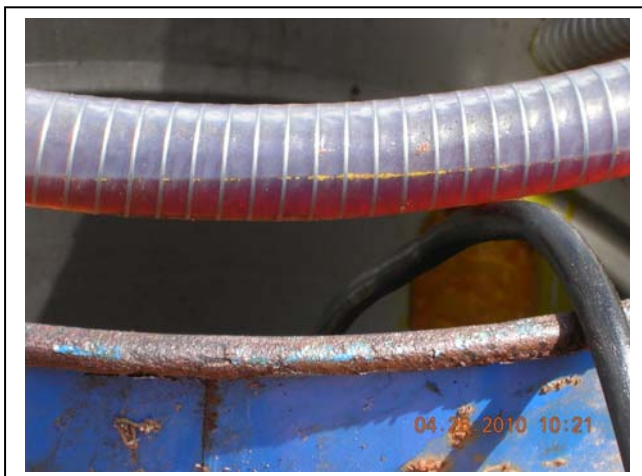
Close up of the recovered oil outlet hose from the test unit

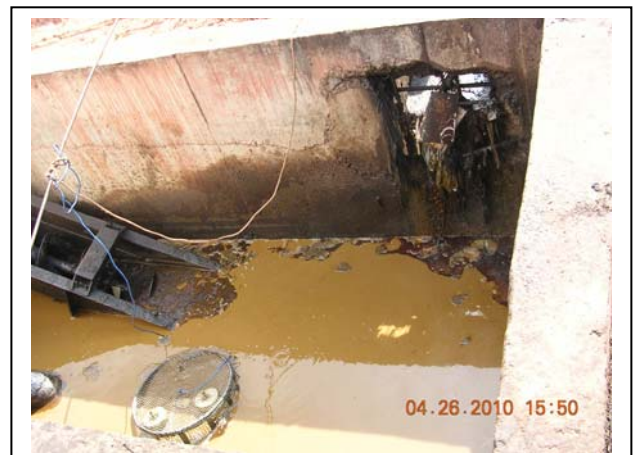
During the afternoon of April 26 almost no more free oil was found in the pit, most of the oil left in the pit is emulsified. In the upper right corner of the picture the outlet canal leading sludge blow down from the existing oil recovery tanks to the pit is seen, and remains of the darker old oil is seen.

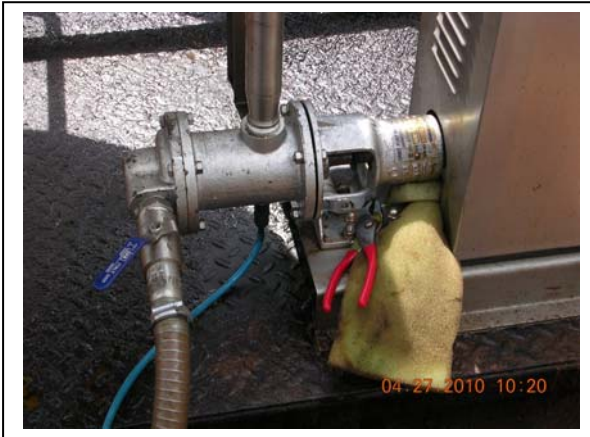
Inaccuracy in the sampling of POME from the pit, resulted in the mounting of a sampling valve and a small hose at the test unit pump (outlet was higher than inlet)

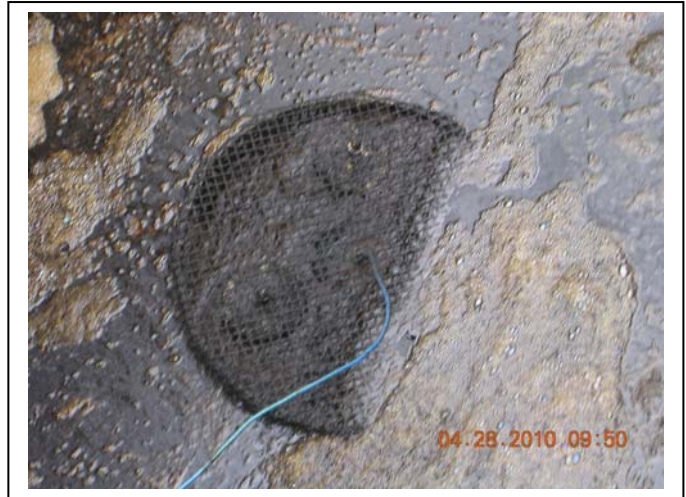
Close up of the oil skimmer; note all the black fiber on the skimmer

The above pictures show oil samples, left at the test site overnight, samples taken on April 27. The black fiber is most probably coming from the decanters; the efficiency of the decanters seems to be slightly reduced at full load. Biomass fiber is known to be very good to soak up oil, and is commonly used in connection with oil spill. It is believed that the fiber content in the POME will soak oil that is then discharged together with effluent from the MORE test unit.
